# Case study on emergency measures for maintenance and re-support of an embankment supporting a bridge abutment

**Sarmad Al-Tameemi**, Oliver Bernecker

GrundWerk GmbH & Co. KG, Stuttgart, Germany, [al-tameemi@gw-gi.de](mailto:al-tameemi@gw-gi.de)

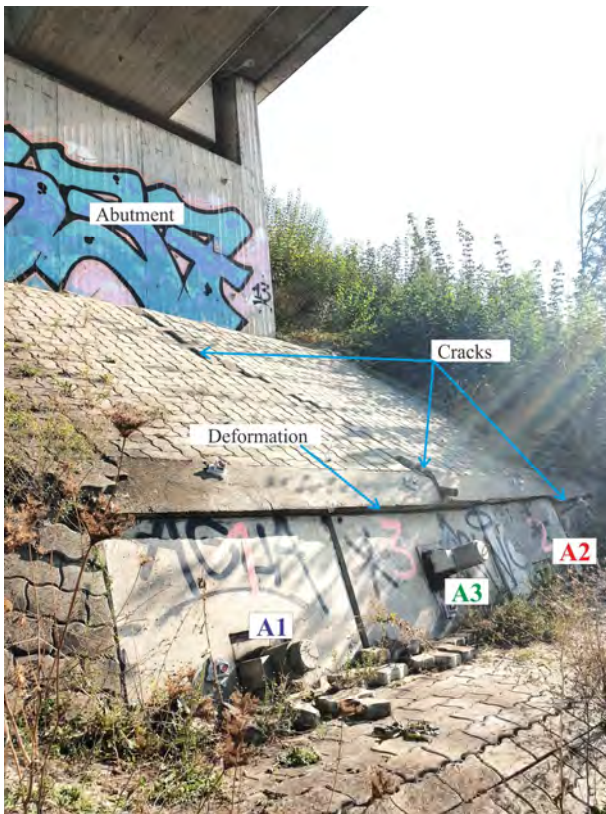
In 2024, noticeable slope movements and service damages were observed in the area adjacent to the northern abutment, raising concerns about the safety of the slope and the bridge foundation. At the interface between the anchor panels and the overlying cobblestone layer, deformations of up to 10 cm were recorded. Significant cracking was observed in the slope surface with maximum crack depths reaching 40 cm and up to 5 cm widths. In addition, the stairway exhibited noticeable horizontal displacement, which caused it to become partially non-functional. Numerous cobblestones became dislodged and fell as a consequence of ongoing slope deformation. Figure 3 and Figure 4 show the deformations and damages in the embankment and stairway.

Figure 3. Cracks and deformation in the cobblestone.

In parallel, the visible damages and deformations were repaired. Specifically, the cobblestone surface and the steps of the stairway were restored to reinstate both serviceability and aesthetic appearance. The remediation includes the additional anchors and soil nails depicted in Figure 14 and Figure 15.

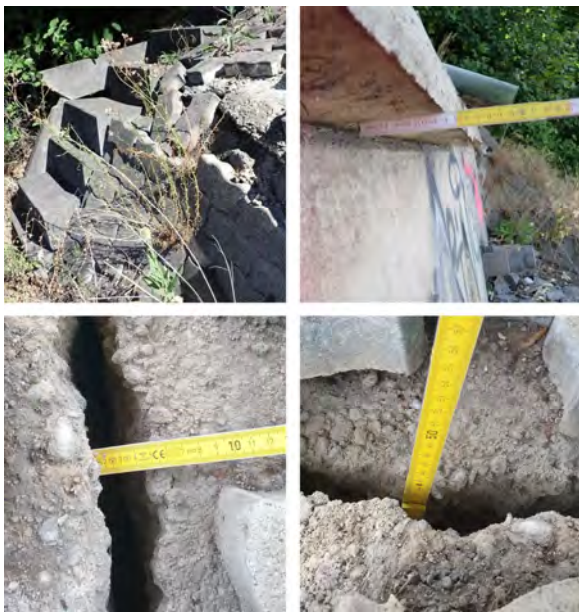
Figure 4. Deformation of the steps and crack measures.

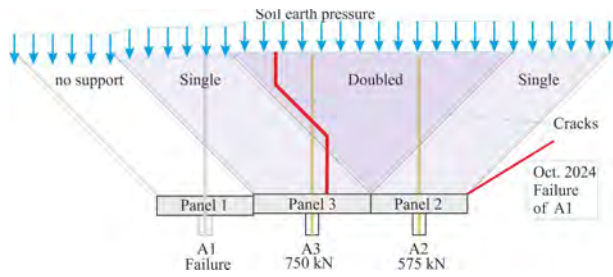
The failure occurred in anchor A1 after the reaction force exceeded its proof load of 150 kN and reached approximately 300 kN. This overload results in a complete loss of its anchorage function. This unbalanced distribution of loads disrupted the equilibrium of the soil-structure interaction,

particularly behind the anchor panels, and led to stress concentrations on one side of the system. The resulting asymmetry in soil pressure between the left and right sides of the slope triggered a local overstressing and ultimately caused cracking and deformation in the slope surface as presented in Figure 7. The resulting stress fields correlate well with the observed crack patterns and provide a logical interpretation of the failure progression.

Figure 7. Stress distribution in soil after the failure in anchor A1.

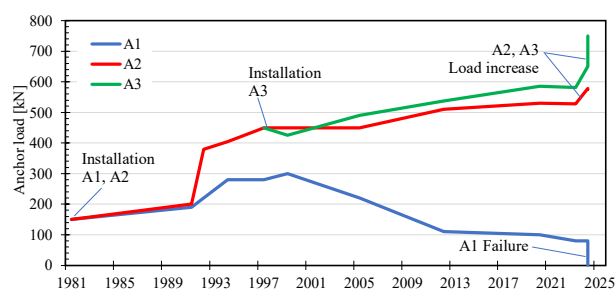
Over the years, the anchor forces continued to increase until 2023, when a sudden drop in the load carried by anchor A1 was recorded, decreasing to 80 kN. Concurrently, the forces in anchors A2 and A3 rose to 528 kN and 581 kN, respectively. One year later, anchor A1 failed completely, without any remaining load contribution, resulting in further increases in the loads carried by anchors A2=575 kN and A3=750 kN. These values significantly exceeded the original design capacities of the respective anchors. This behavior is comparable to the finding of Daxer et al. (2024) that noticed in a 3D numerical simulation and analysis, that the stress redistribution after an anchor failure in an anchor group, caused an increase in load of the adjacent anchors up to 21%.

Figure 8. Measured load of the existing anchors.

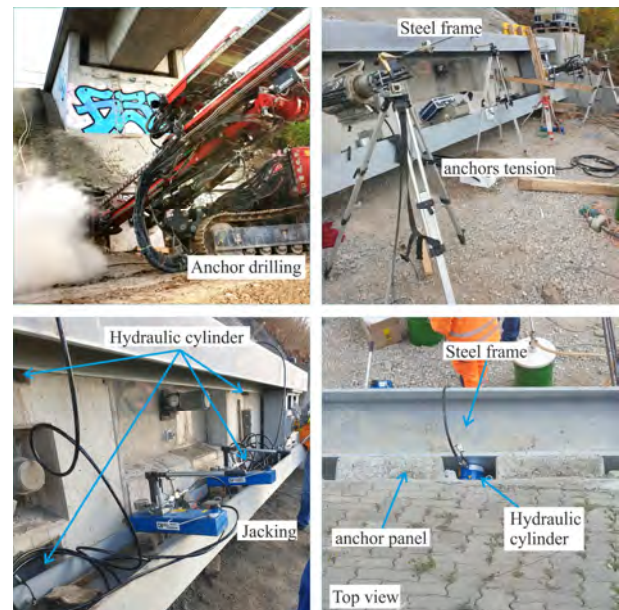
Figure 10. Installation of the additional anchors with jacking system.

The initial loading steps were carried out on the outer anchors A4 and A7 at the same time, in increments of 50 kN up to a total load of 150 kN. Subsequently, the same loading procedure was applied to the inner anchors, A5 and A6. Shortly after the lock-off of anchors A5 and A6, a redistribution of loads occurred within the system, resulting in an increase in the load on anchor A7 to 173 kN and a reduction on anchor A5 to 140 kN. To restore balance within the system, hydraulic jacking was performed, primarily on Panel 1 (left side), in order to increase the load carried by anchors A4 and A5. Following this adjustment, the anchor loads stabilized at A4=160 kN, A5=147 kN, A6=146 kN, and A7=169 kN. This final load configuration reflects a symmetrical distribution across the new anchorage system.

After 20 days, a reduction in anchor loads was observed, which was likely due to the strand strain (elongation) in the free length of the anchors. As a result, re-jacking was necessary to restore adequate support loads and to prevent further displacement of the slope. The re-jacking procedure was carried out similarly to the previous adjustment, with a focus on the left side of the system where the load reduction was more pronounced. Following the re-jacking, the loads stabilized at A4=171 kN, A5=162 kN, A6=128 kN, and A7=150 kN. The loading steps are listed in Table 3. The installation of the additional anchors with the jacking system is shown in Figure 10.

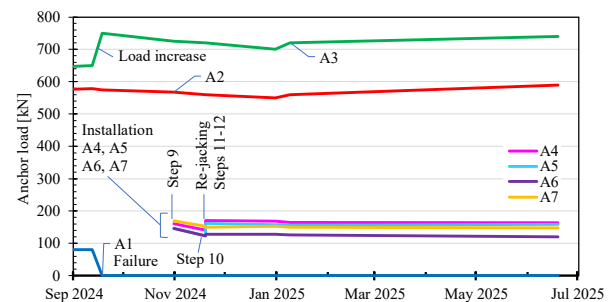
During the installation of the additional support system and in the subsequent monitoring period, the existing anchors A2 and A3 exhibit slight fluctuations in the recorded load measurements. These variations are likely attributable to temperature changes, which can influence the accuracy of pressure gauges and load cells. Figure 11 shows the measured load for the existing as well as the new additional anchors.

Figure 11. Measured load of the anchors after the installation of the additional anchors.

The newly installed anchors (A4–A7) effectively carried the reaction loads, fully compensating for the failed anchor A1. Since then, no significant change in anchor forces has been observed; therefore, the load distribution has remained stable and within the design limits, as it is clearly noticed in Figure 11.

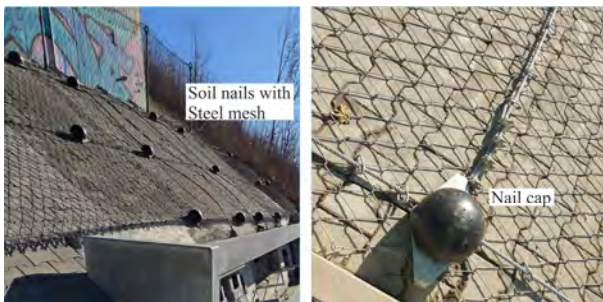
Figure 13. Soil nail with steel mesh.

The soil nails were combined with a high-tensile steel mesh installed across the surface of the embankment. This mesh facilitates the distribution of loads between the nails over the surface area of the embankment, thereby providing surface stability and preventing shallow slips. In addition, it serves as a protective barrier, preventing cobblestones from detaching and falling onto the highway below, as shown in Figure 13.

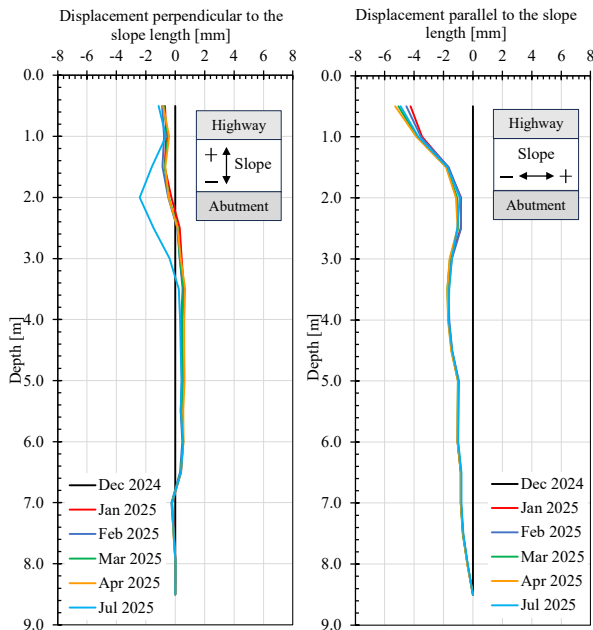
Inclinometer data revealed that within the first month following the remediation, the slope experienced a lateral displacement parallel to the highway direction of approximately 4.5 mm. Thereafter, the rate of movement decreased significantly. Within the subsequent measurements, an additional displacement of about 1 mm takes place, as shown in Figure 17.

Figure 17. Slope deformation in both directions – inclinometer results.
