# Case study on emergency measures for maintenance and re-support of an embankment supporting a bridge abutment

**Sarmad Al-Tameemi**, Oliver Bernecker

GrundWerk GmbH & Co. KG, Stuttgart, Germany, [al-tameemi@gw-gi.de](mailto:al-tameemi@gw-gi.de)

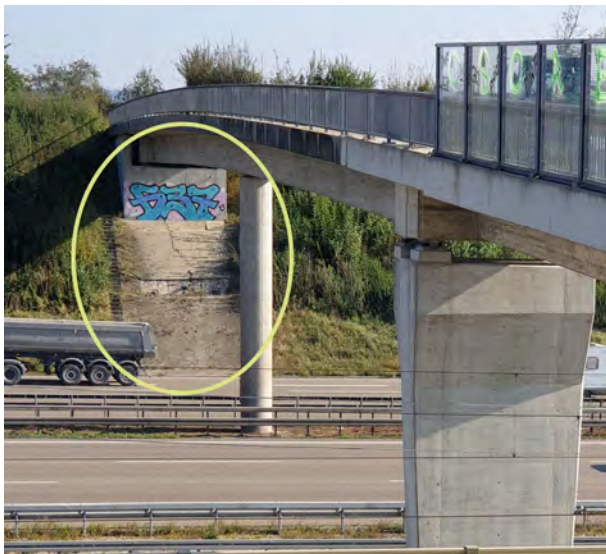
Figure 1. General view of the bridge toward the north abutment.

In 2024, noticeable slope movements and service damages were observed in the area adjacent to the northern abutment, raising concerns about the safety of the slope and the bridge foundation. At the interface between the anchor panels and the overlying cobblestone layer, deformations of up to 10 cm were recorded. Significant cracking was observed in the slope surface with maximum crack depths reaching 40 cm and up to 5 cm widths. In addition, the stairway exhibited noticeable horizontal displacement, which caused it to become partially non-functional. Numerous cobblestones became dislodged and fell as a consequence of ongoing slope deformation. Figure 3 and Figure 4 show the deformations and damages in the embankment and stairway.

On the other hand, the abutment exhibited a noticeable rotation, as it can be noticed that the joint on the pavement between the bridge and the abutment was smaller on the west side and bigger on the east side of the pavement. However, the bridge and piers show some insignificant signs of cracks and remain functional.

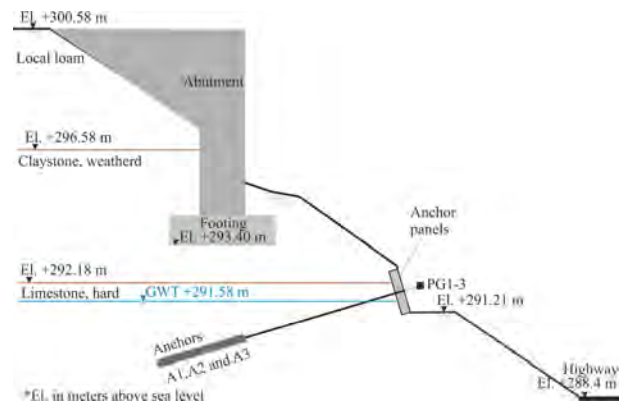
This study focused on the northern embankment, which was supported by two ground anchors (A1 and A2) and later with additional anchor A3; these are accompanied by pressure load gauges (PG) for continuous monitoring of the anchor load over the lifespan. The embankment has an overall height of approximately 12.0 m and about 18.0 m width, with an average inclination of 33°. In the area adjacent to the bridge abutment, the embankment extends over a length of roughly 12.0 m. The abutment footing is embedded at 7.5 m depth below the highest point of the embankment surface, while the anchor heads are installed at 1.5 m beneath the base of the footing.

relieve hydrostatic pressure, a drainage pipe was installed above the level of the anchors. Figure 2 presents a side view for the embankment with the existing anchorage system.

Figure 2. Side view of the embankment and abutment with the existing anchorage system.

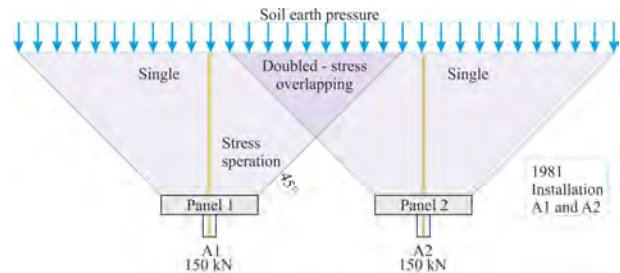
The anchors were originally designed to carry a load of 400 kN. However, subsequent investigations revealed that anchor A1 could only sustain a maximum load of 175 kN, whereas anchor A2 retained its full load-carrying capacity  $\geq 400$  kN. As a precautionary measure and to maintain overall slope stability, both anchors were stressed to a lock-off load of 150 kN.

The anchors were originally designed to generate a uniform reaction stress to stabilize and retain the soil mass behind the anchor panels. Figure 5 illustrates in top view the reaction distribution of stress behind the anchor panels and the overlapping zones of stress influence between the anchors by assuming a simplified 1:1 stress dispersion model.

Figure 5. Stress distribution in soil after installing anchors A1 and A2.

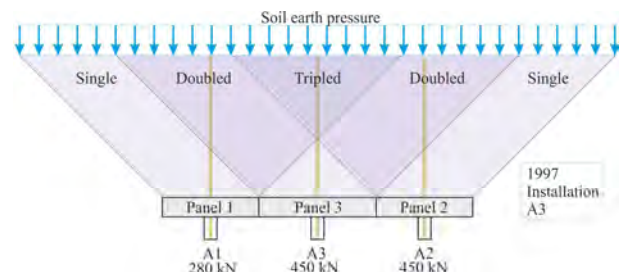
In 1997 (16 years after the original installation), it was observed that the anchor forces had increased to A1=280 kN and A2=450 kN, thereby exceeding their design capacities. To mitigate the risk of structural failure and ensure long-term stability for the slope, it was decided to install an additional anchor A3 located between the two old anchors. This measure aimed to redistribute the loads more effectively, transferring the forces from two to three anchors. The load at anchorage (lock-off load) for this anchor was A3=450 kN with designed carrying capacity of 600 kN. In this stage, the resulting stress distribution in the soil behind the anchor panels increased, especially in the middle and right side around anchors A2 and A3, as shown in Figure 6.

Figure 6. Stress distribution in soil after the installation of anchor A3.

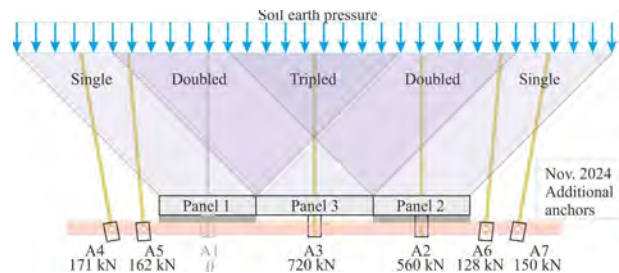
Figure 12. Stress distribution in soil after installing the additional anchors A4, A5, A6 and A7.

The four additional anchors were installed and connected to the compensatory steel frame. This frame was supported by the new anchors and braced exclusively against the existing panels 1 and 2 corresponding with anchors A1 and A2. Using hydraulic jacks, particular emphasis was placed on reactivating the soil reaction behind the left-side panel 1, thereby rebalancing the load distribution and restoring stress equilibrium behind the anchorage system. As illustrate in Figure 12, a redistribution of the stress behind the anchor panels is ensured, which has a considerable contribution to the reduction of the stress asymmetry behind the panels.

The supporting additional anchorage system has the capacity to support more increments in load and redistribute the associated stress on the both sides for the long-term lifespan of the structure. Furthermore, any stress unbalanced in the system can be controlled and adjusted via the hydraulic jacks.

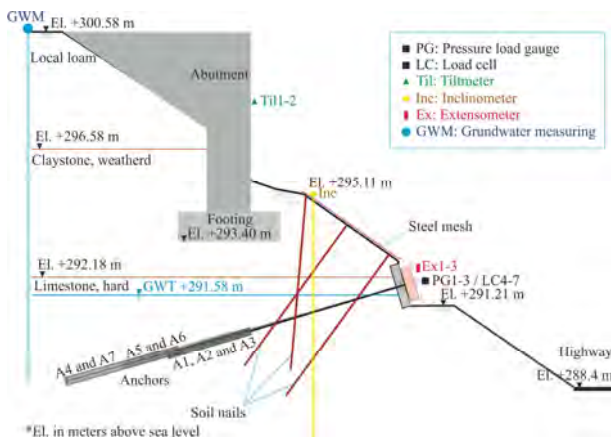
Figure 14. Side view – remediation measures and monitoring system.

In parallel, the visible damages and deformations were repaired. Specifically, the cobblestone surface and the steps of the stairway were restored to reinstate both serviceability and aesthetic appearance. The remediation includes the additional anchors and soil nails depicted in Figure 14 and Figure 15.

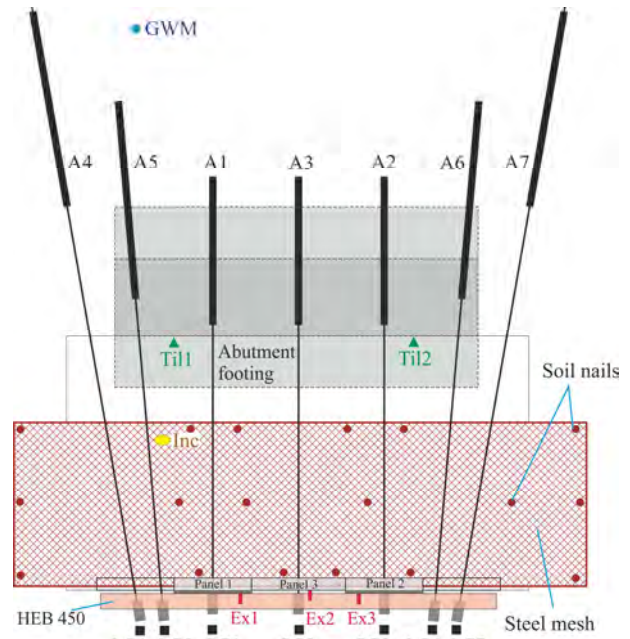
Figure 15. Top view – remediation measures and monitoring system.

The instrumentation includes: Load cells installed at the heads of the newly added anchors to continuously measure anchor forces; An inclinometer, was used in a vertically cased borehole, recorded lateral ground movements at various depths of the embankment; Extensometers were used to monitor the displacement of the existing anchor panels along the direction of the anchor strands; Tiltmeters used on the abutment to detect rotational movements around two axes; And a groundwater monitoring well implemented to observe real-time changes in the groundwater table, which could affect slope stability. Figure 14 and Figure 15 display the location of the sensors over the embankment and the anchorage system. Figure 16 displays a view after the implementation of remediation measures.

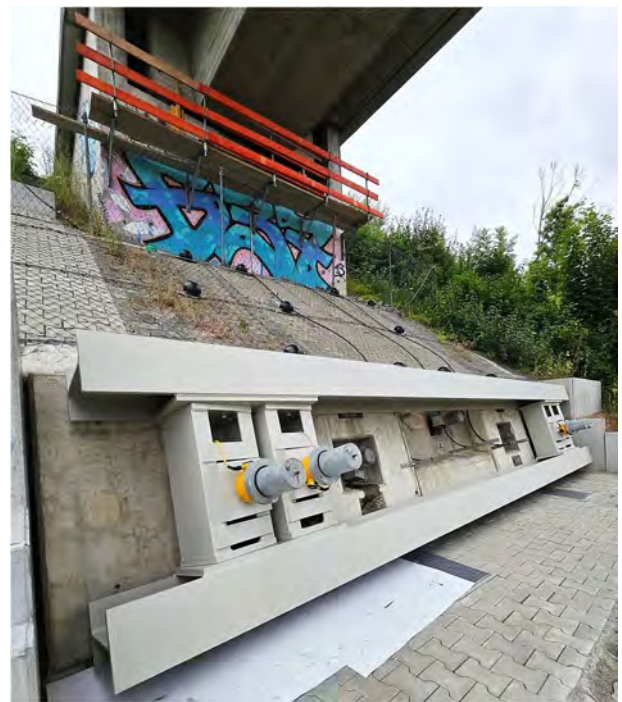
Figure 16. General view for the embankment after the remediation.

The consistent results from the monitoring system confirm that the slope remains in a stable condition. Furthermore, no additional visible cracks or structural damages have been observed on the embankment surface or the stairway.
